Approved For Release 2003/03 SECRETA-RDP78T05161A001300010016-8				
		25X1		
!	DDI IMAGERY ANALYSIS STAFF	PIR 75093

This report summarizes significant items of photo intelligence relating to the North Vietnamese railroad system which has been developed from available photography (received by the CIA Imagery Analysis Staff) during the period indicated on the cover. This report is intended to provide a comprehensive view of the railroad system and does not necessarily reflect the most recent status changes as reported by pilots' reports or field photo intelligence cables.

Those portions of the Hanoi/Lao Cai and Thai Nguyen Rail Lines covered by interpretable photography were open to through traffic. One bridge interdiction was noted on the Hanoi/Dong Hoi Rail Line, and a rail-to-rail transloading operation has been observed at the Thanh Hoa Railroad Yards.

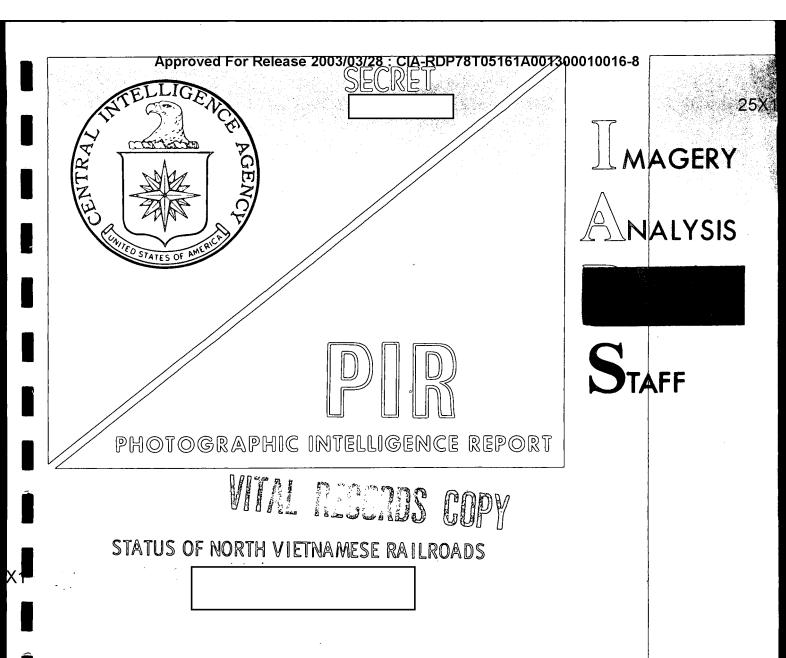
Approved For Release 2003/03/36CRQIA-RDP78T05161A001300010016-8 PIR 75093**25X1** FIGURE 1 NORTH VIETNAMESE RALLROAD SYSTEM TUXER BIEN GULFNOUN VIETN HAINAN TAO OFTONKIN ENTIANE NONG KHAI MUANG HON PHANOM UDON THA DEMARCATION LINE NPIC BASE 11 DONG HA NAUTICAL MILES

The railroad system has been divided into 5 major lines: the Hanoi/Lao Cai Line, the Hanoi/Dong Dang Line, the Hanoi/Haiphong Line, the Hanoi/Dong Hoi Line and the Thai Nguyen Line (Figure 1). Annotated maps and photos are used to show the status of each line.

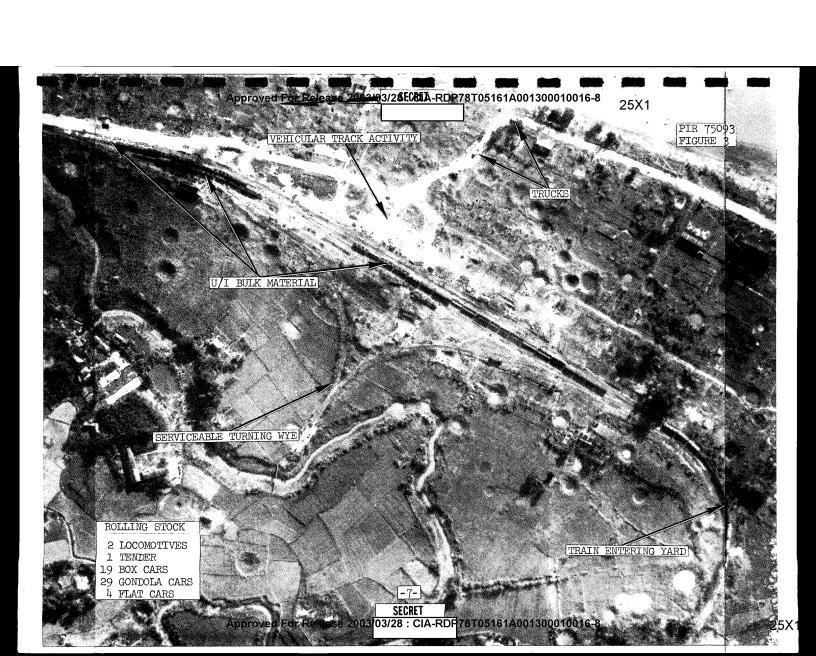
Approved For	r Rele	ase 2003/0 3 2 REI A-RDP78T05161A0013000	10016-8
			DDI IMAGERY ANALYSIS STAFF	TR 75093
•	ITEM OF INTEREST NO	. 1:	Hanoi/Lao Cai Rail Line	
	NAME	:	Yen Bai Railroad Yard	
X1	BE	:		
	COORDINATES	:	21 42N - 104 53E, VJ880996	
	PHOTO REFERENCE	:] 25X1
	MAP REFERENCE	:	JOG (A) 1501, NF 48-10	
	23, November and Dec Yard is once more so I locomotive, 11 em and 11 box cars (app consisting of a loco	cembe ervic pty g proxi omoti	usly reported U.S. airstrikes (Report Nor 1966) has been repaired and the Yen Reable. On the yard condola cars, 15 loaded gondola cars, 4 mately), all of which are serviceable. The year tender, 8 box cars, 2 empty gond was entering the yard from the south.	Bai Railroad ontained flat cars, A train

indicates that transshipment activity is presently occurring.

Extensive vehicular track activity adjacent to the rail yard strongly

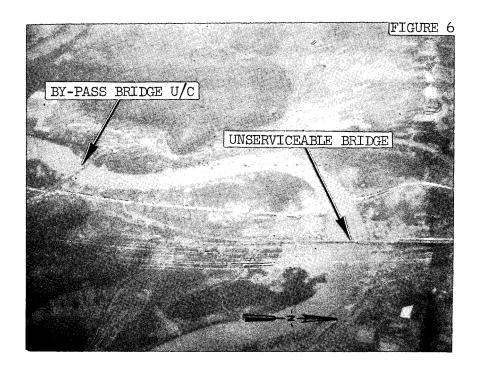
ITEM OF INTEREST NO. 1: Hanoi/Dong Hoi Rail Line

: Tam Da RR. and Hwy. Bridge

Approximately 4 spans of the probable 12-span, deck-beam Tam Da Railroad and Highway Bridge have been destroyed. The by-pass bridge is also unserviceable.

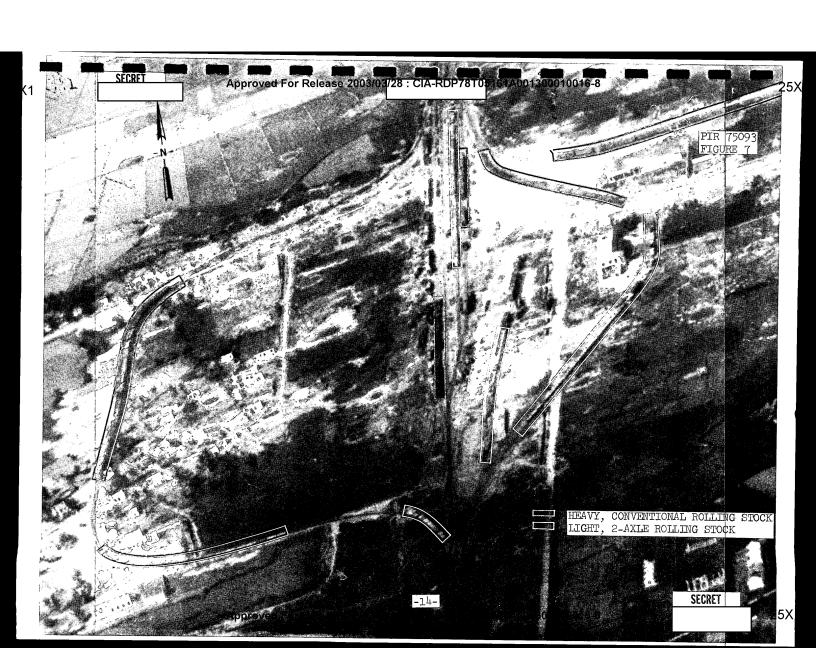
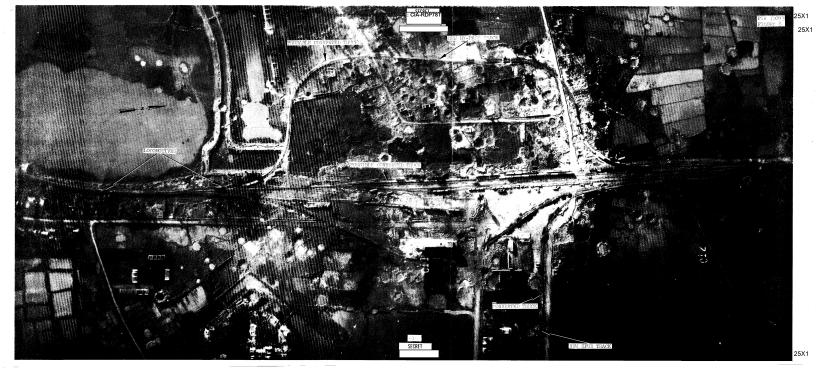
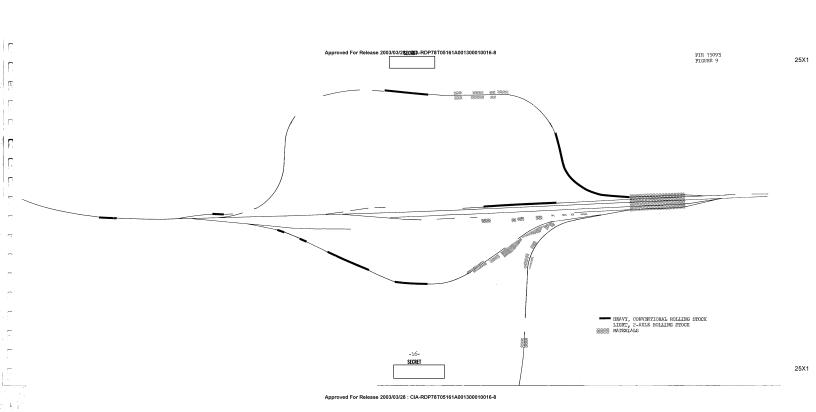
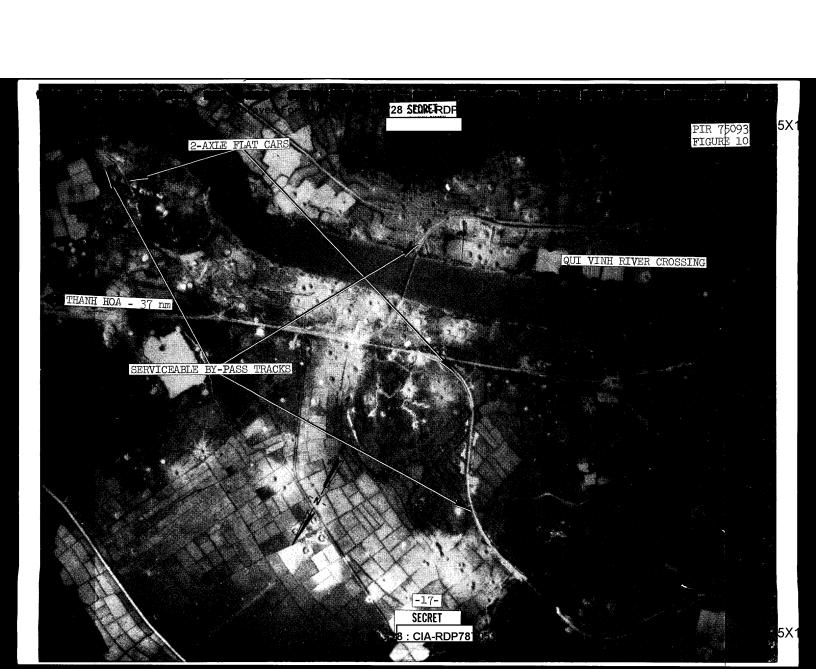
Approved For Relea	ase 2003/03/ 3&CRF TRDP78T05161A00130	00010016-8 25X1
		DDI IMACERY ANALYSIS STAFF	PIR 75093
		DDI IMAGERY ANALYSIS STAFF	
	ITEM OF INTEREST NO. 2:	Hanoi/Dong Hoi Rail Line	
	NAME :	Thanh Hoa RR. Yards	
	BE 25X1 :		
	COORDINATES :	19 48N - 105 46E, WG807906	
	PHOTO REFERENCES :		051/4
			25X1
	MAP REFERENCE :	JOG (A) 1501, NE 48-3	
	in open storage in the T	distribution of rolling stock and m hanh Hoa Railroad Yards has lead to used as a major transloading area.	
		s located at the western edge of Thrd with 2 by-passes and 2 dead-end	
25X1	noted on the dead-end sp the northern portions of noted on the dead-end sp	Figure 7), heavy, conventional rolur located at the northern edge of the 2 by-passes. Light, 2-axle rour on the southern edge of the rails of the 2 by-passes. The rolling s	the yard and on lling stock is road yard and tock is more
25X1	adjoining tracks, includ Large amounts of materia beams, and probable wood	although the two difed. See Figure 9 for a line drawing ling the distribution of rolling stools in open storage, including rails len beams are found along the by-passe northern dead-end spur (Figures 8	of the yard and ck and supplies. , probable steel ses, within the

ventional steam locomoti Hanoi to the Thanh Hoa R portion of the yard. Li portion of the yard and These cars, using conver	heavy, conventional rolling stock ves, is transporting materials sout ailroad Yards and off-loading withing the 2-axle rolling stock is held in on unused by-pass tracks south of the trucks for motive power, subsequents the track and probably start their	hward from n the northern the southern he yard (Figure 10). uently on-load
	construction of the hast tates extremely light ro detailed information con	transloading operation is probably ily reconstructed bridges south of alling stock (see Report No. 9, Sept acerning the specifications of the 2 ing stock is easier to conceal or c	Thanh Hoa necessi- ember 1966 for -axle flat cars),
25X1	all of the 2-axle flat c	ears in the Thanh Hoa Railroad Yards	on [
			•

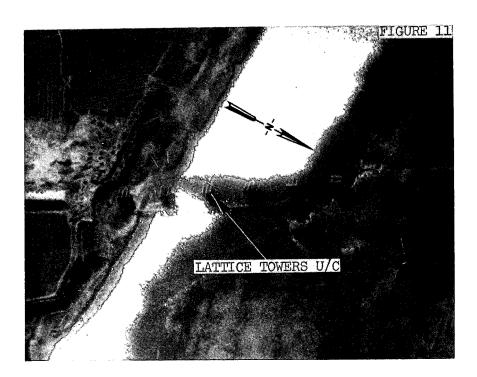
ITEM OF INTEREST NO. 3: Hanoi/Dong Hoi Rail Line

: Phuong Dinh RR. By-Pass Bridge E

An 8-span, by-pass bridge is under construction approximately 500' east of the currently unserviceable main bridge and 600' east of a currently serviceable by-pass bridge

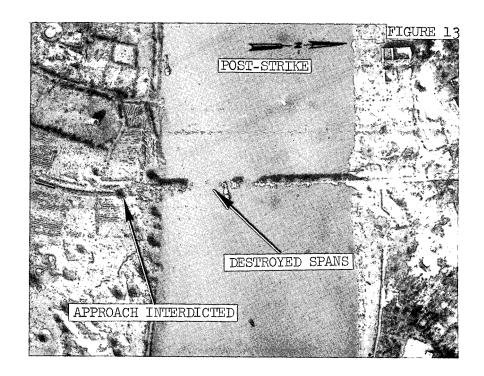
Approved For Relea	se 2003/03/ §∉ (℟ ℻RDP78T05161A001300	010016-8
	DDI IMAGERY ANALYSIS STAFF	PIR 75093
ITEM OF INTEREST NO. 4:	Hanoi/Dong Hoi Rail Line	
NAME :	Dong Phong Thuong RR. Bridge E	
BE :		
COORDINATES :	19 58N - 105 51E, WH890090	•
PHOTO REFERENCES :]
		J
MAP REFERENCE :	JOG (A) 1501, NE 48-3	
Bridge E have been destr This bridge was services	ons of the deck-beam Dong Phong Thuon coyed and 1 approach has been interdible on Figure 12). The emains unserviceable.	cted (Figure 13).
	ng Railroad By-Pass Bridge S rail line is interdicted at both en	has ds of the

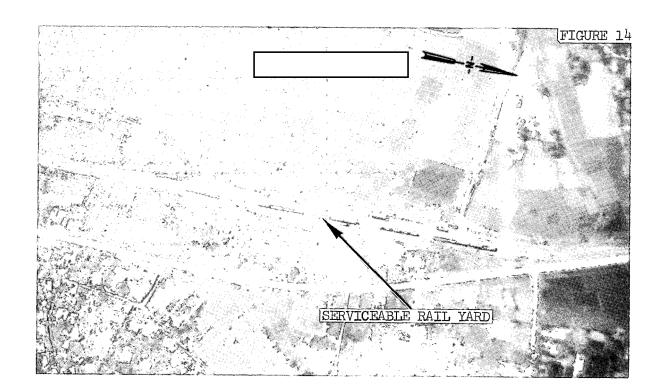
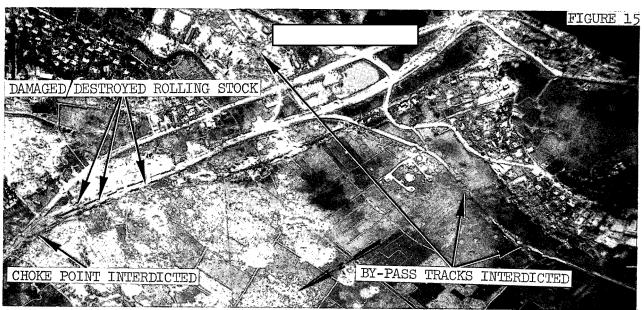
Approved I	For Relea	ase 2003/03/ % (RE TRDP78T05161A0	01300010016-8 25X1
		DDI IMAGERY ANALYSIS STAFF	PIR 75093
ITEM OF INTEREST	NO. 5:	Hanoi/Dong Hoi Rail Line	
NAME	:	Dong Phong Thuong RR. Yard	
BE	:	NA	
COORDINATES	0	19 59N - 105 46E, WH886109	
PHOTO REFERENCE	:		25X1
MAP REFERENCE	:	J O G (A) 1501, NE 48-3	
(Figure 14). At 14 probable box serviceable. Photank car, 2 box or damaged and a several places. south of the yard	that ticars, 5 otograph cars, 2 ll through of d, the t	gondola cars, and 6 flat cars he igh tracks in the yard have been the choke points has been interested by pass tracks of the Dong Pi	ately 6 tank cars, all of which were) reveals that 1 ave been destroyed interdicted in dicted. Immediately hong Thuong Railroad
and Highway Bridg		have been interdicted

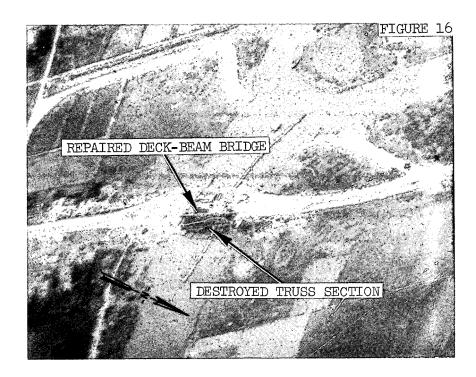
ITEM OF INTEREST NO. 6: Hanoi/Dong Hoi Rail Line

: Ha Thon RR. Bridge

The probable 3-span, deck-beam Ha Thon Railroad Replacement Bridge has been repaired and is serviceable to through traffic.

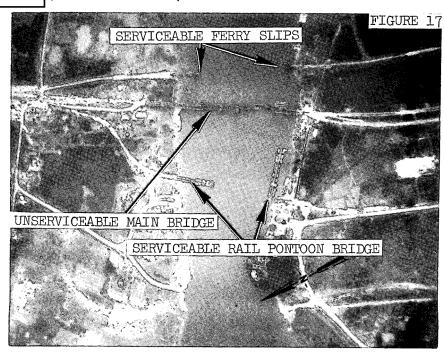
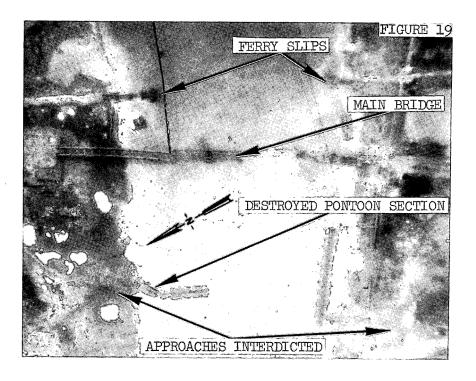
ITEM OF INTEREST NO. 7: Hanoi/Dong Hoi Rail Line

Photography of _______ reveals a serviceable railroad pontoon bridge (Figure 17) over the Ninh Binh river crossing immediately to the west of the unserviceable main bridge _______ This pontoon 25X1 bridge is presently not being used. The railroad ferry immediately to the east of the main bridge remains serviceable. The rail ferry boat associated with this crossing has been moved from its previous location at UTM XHO34400 to a point 2.2 nm (approx.) east of the main bridge at UTM XHO73391 (Figure 18).

On photography of ______ the railroad pontoon bridge has been struck and is unserviceable (Figure 19). One probable pontoon section has been destroyed and both approaches have been interdicted. The nearby ferry slips are undamaged and a by-pass, the Ninh Binh Railroad Bridge - ______ (not illustrated) remains serviceable.

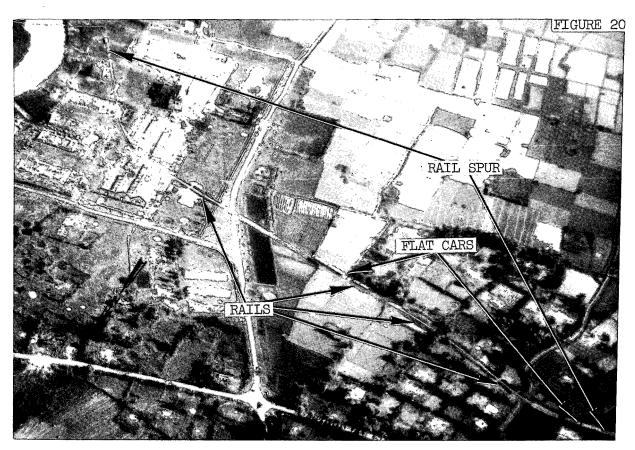
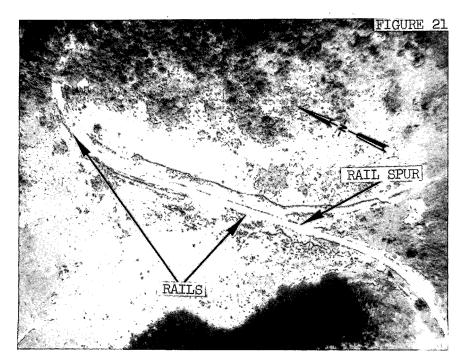
Large quantities of rail have been observed along the Hanoi-Vinh segment of the rail line (Figure 5). The Thanh Hoa Railroad Yards (Item of Interest No. 2) constitute the largest area of rail storage. Surplus rails have also been stacked in quantity at 19 43N - 105 43E (Figure 20) and 20 28N - 105 42E (Figure 21) as well as at 19 22N - 105 44E, 19 24N - 105 44E, and 19 27N - 105 46E. Nineteen motionless flat cars carrying a total of 11 stacks of rail were noted at 19 16N - 105 42E (not illustrated).

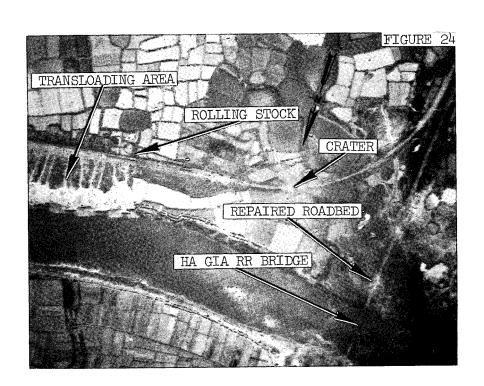
ITEM OF INTEREST NO. 1: Thai Nguyen Railroad Line

The spur line to the Ha Gia transshipment area has been interdicted in 1 place. At least 4 pieces of undamaged rolling stock are located in the transshipping area, indicating that the area has been active. The

25X1 Ha Gia Railroad Bridge appears serviceable, although the southern approach has been cratered and repaired.
